Contract #: 04-0120F4Cty: SF/ALA Rte: 80 PM: 13.2/13.9File #: 13.28**WELDING INSPECTION REPORT****Resident Engineer:**Pursell, Gary**Address:** 333 Burma Road**City:** Oakland, CA 94607**Report No:** WIR-008787**Date Inspected:** 02-Sep-2009**Project Name:** SAS Superstructure**OSM Arrival Time:** 1900**Prime Contractor:** American Bridge/Fluor Enterprises, a JV**OSM Departure Time:** 330**Contractor:** Oregon Iron Works Clackamas, Or.**Location:** Clackamas, OR**CWI Name:** Steve Barnett, Jon Nickolich**CWI Present:** Yes No**Inspected CWI report:** Yes No N/A**Rod Oven in Use:** Yes No N/A**Electrode to specification:** Yes No N/A**Weld Procedures Followed:** Yes No N/A**Qualified Welders:** Yes No N/A**Verified Joint Fit-up:** Yes No N/A**Approved Drawings:** Yes No N/A**Approved WPS:** Yes No N/A**Delayed / Cancelled:** Yes No N/A**Bridge No:** 34-0006**Component:** Hinge-K Components**Summary of Items Observed:**

Summary of Items Observed: On this date, Caltrans Quality Assurance Inspector (QA) Clete Henke was present at Oregon Iron Works, Inc. (OIW) in Clackamas, OR for observation of fabrication of the Hinge K Pipe Beams and related activities including in process welding a

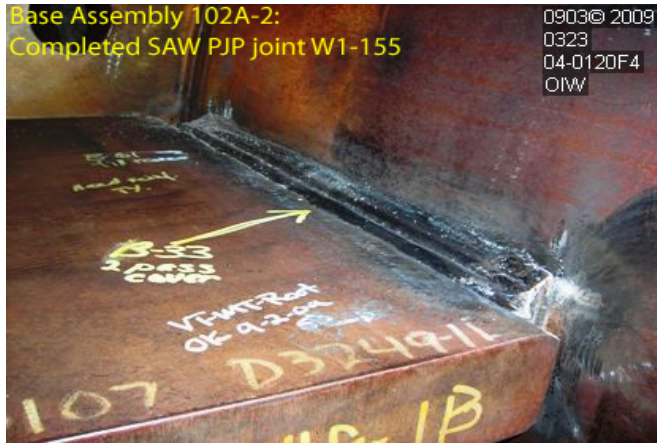
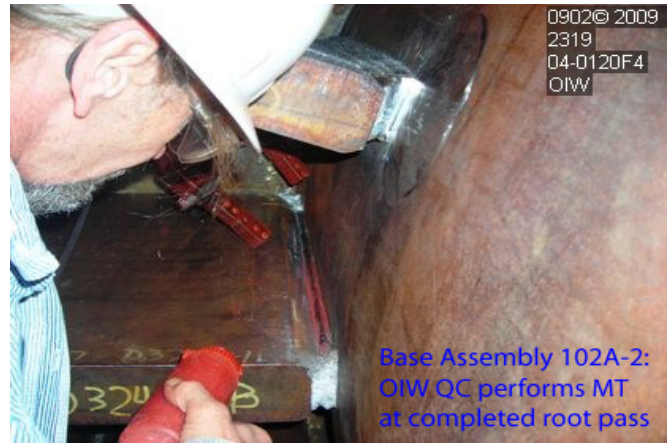
H4) on swing shift and Harold Baldonado (WID B33) on graveyard shift during in progress Submerged Arc Welding (SAW) at weld joints W1-136, W1-134, W1-157 & W1-155. The referenced connections join various radial stiffeners to a111-4 forging. The QA Inspector observed as OIW QC Inspector Steve Barnett performed Magnetic particle Testing (MT) and Visual Inspection (VT) of completed root pass at weld joints referenced above. Mr. Barnett stated that he had located no rejectable indications. The QA Inspector subsequently performed 100% VT & 50% MT verification at the noted locations W1-136 & W1-155 finding the root passes to be in general compliance with contract documents. Please reference TL-6028 report for this date for details. The QA Inspector intermittently observed as welders B61, H4 & B33 deposited SAW passes in the horizontal (2F) position in accordance with approved welding procedure 4016. The QA Inspector noted the OIW welders were maintaining continuous preheat utilizing a torch. Referenced connections W1-136, W1-134 & W1-157 were completed during the swing shift and W1-155 was completed during graveyard shift. The QA Inspector observed OIW QC Inspectors Steve Barnett and Jon Nikolich regularly monitoring and recording the in process SAW parameters during swing and graveyard shift respectively. The QA Inspector also intermittently observed in process welding parameters and determined that the SAW parameters and minimum preheat/interpass temperature appeared to be in general compliance with the contract requirements -- (W1-134: 35 volts, 565 amperes, 432mm/min travel speed ).

The QA Inspector intermittently observed OIW qualified welder Vincent Vu (WID V7) during in-process welding of Soudotape 316L stainless steel overlay to hinge k pipe beam fuse sub-assembly 120A-7. The weld joint is identified as 316L 3rd Layer. Mr. Vu was observed welding in the flat position utilizing automatic electro slag welding (ESW) overlay process with a .5mm x 60mm Soudotape 316L stainless electrode, filler metal brand Soudotape class EQ316L automatic. An OIW helper was observed assisting welder V7 during ESW activity. The QA Inspector observed OIW QC Inspector Steve Barnett regularly monitoring and recording the in process ESW parameters. The QA Inspector also intermittently observed in process welding parameters and determined that the ESW parameters (1200 amps, 25.2 volts, 267mm/min travel speed) and minimum preheat temperature of 70° F appeared to be in general compliance with the contract requirements and approved OIW Welding Procedure Specification (WPS) 7003. ESW activity was paused at about 2300 hours prior to shift turnover and was not resumed during graveyard shift.
